# Evaluating Quality of Piles Constructed in Indonesia Through Five Year of Crosshole Sonic Logging Data

**KEYWORDS** Indonesia Construction; Foundation; Crosshole Sonic Logging (CSL); Database Study

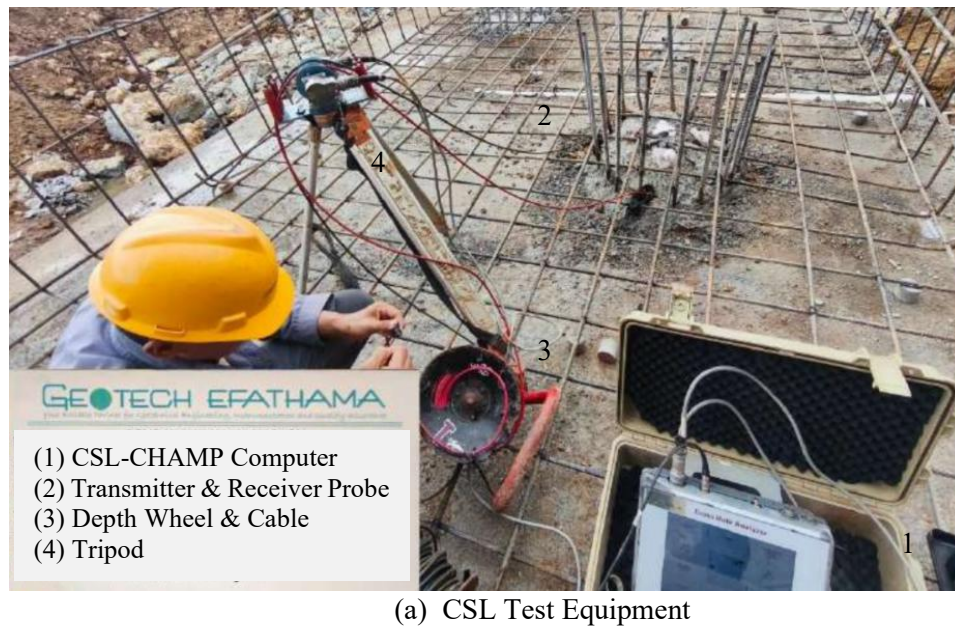
diaphragm walls, barrettes, and dams. Under this standard, all such elements are collectively designated as “deep foundation elements.” CSL measures the propagation time and relative energy of an ultrasonic pulse emitted from a transmitter to a receiver placed at different access ducts (crosshole), using pre-installed tubes embedded prior to casting of a deep foundation element.

Figure 1. Crosshole sonic logging test

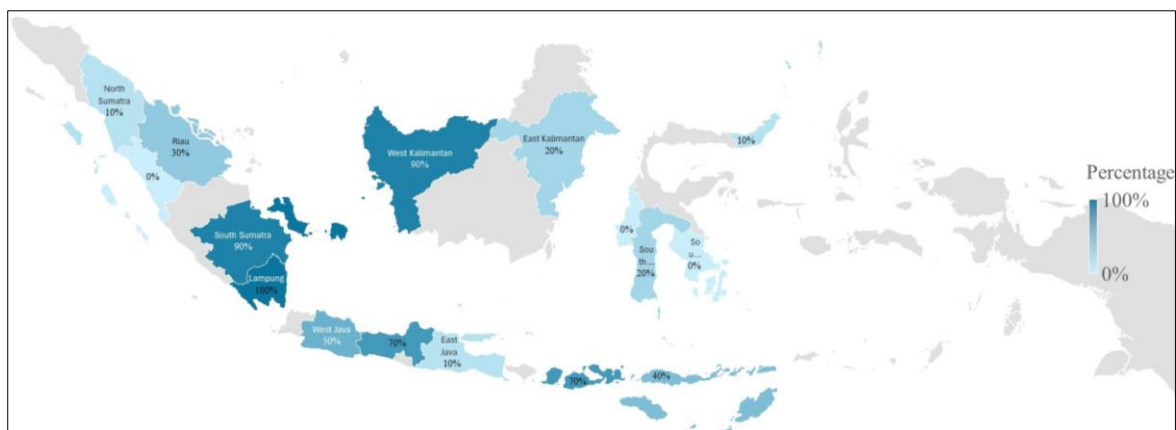
Figure 9. Distribution of percentage pile with defects

Next, the acceptable piles (Class A) and piles with defects (Class B & C) are recategorized based on their location. This is to examine the construction quality across various region. Table 5 shows the test results categorized by islands in Indonesia. Java has the largest share of defective piles, representing about 82% of all pile defects recorded. However, do note that more than 70% of the data is from Java Island. The island with the highest proportion of pile defects is Southeast Islands, in which 60% of the tested piles show defects, followed by Java with 37%. Figure 9 illustrates the distribution by province rather than by island. The data indicate that the highest percentages of pile defects occurred in four provinces: Central Java, South Sumatra, Lampung, and West Kalimantan.
