Weathering of Volcanic Rocks in Baturappe Formation and Its Implications for Foundation Planning of Pamukkulu Dam, South Sulawesi, Indonesia

ABSTRACT The presence of weathered volcanic rocks in Pamukkulu area is important in determining the location and construction of the Pamukkulu main dam and plinth structure. In general, volcanic rocks have poor geotechnical characteristics due to varying degree of weathering, influence of groundwater, and systematic joints produced by cooling lava. This study aims to study the type and quality of weathered rock around the main dam and plinth area. First, mapping of surface geology was carried out. To evaluate the degree of weathering, rock resistivity data is used around the main dam area. Whereas for the plinth area, the bearing capacity of soil/rock is evaluated using Plate Bearing Test (PBT) and Standard Penetration Test (SPT). Bearing capacity obtained from PBT that were carried out on rock surface can be used to interpret rock weathering. In addition to SPT, the coring from rock drilling was also evaluated using Rock Quality Designation (RQD). It was found that the rock up to 20 m depth are of poor quality. It is recommended that the poo

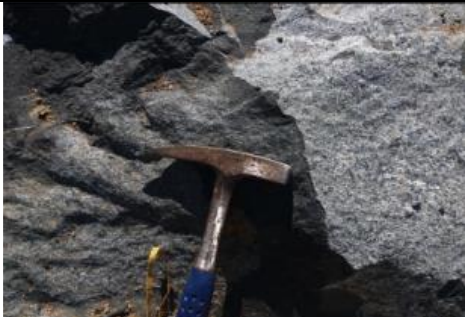
ID	Station	Description	Figure
1	STA 0+200 from center of dam	Basalt. Physical characteristics: fresh color is blackish gray and weathered color is brownish gray, hypocrySTALLINE crystallinity texture, aphanitic granularity, subhedral-anhedral shape, inequigranular relation, massive structure (Fenton and Fenton, 1940).

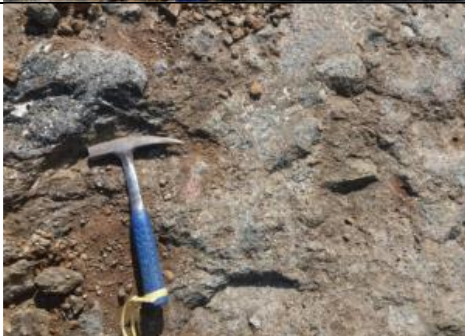
2	STA 0+321 from center of dam	Volcanic Breccia. Physical characteristic: fresh color is gray and weathered color is brownish gray, massive structure has basal fragments measuring 16-256 mm, with a matrix measuring 4-64 mm, and cement measuring 1/8-1/256 mm.

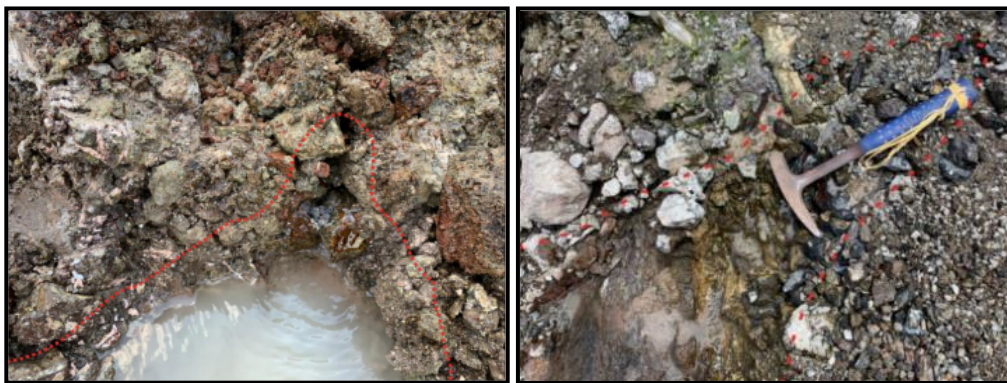
Figure 4. Seepage in Dike

Cracks and continuous joints that undergo weathering can result in weak zone. As a result of this zone, surface seepage is found in several places, such as in the dam site area where the surface seepage zone is in hack X (Figure 2), surface seepage which has large discharge was found due to the rock having undergone very high weathering, causing the rock to turn into soil. Seepage zones were also found in plinth areas caused by continuous weathering of joints. Seepage zones can also be found in cracks and joints that have weathered into weak zones, causing the rock to contain water as seepage (Figure 4).

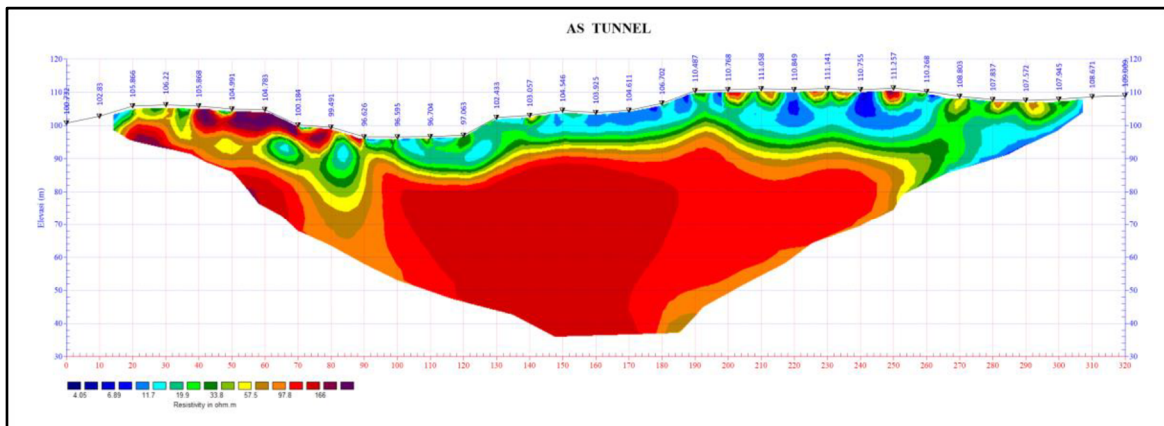
Figure 5. Geoelectric measurement: (a) main dam and center of plinth structure; (b) plinth structure; (c) tunnel; (d) intake; (e) spillway

Figure 5 shows the results of the geoelectric measurements. The measurement of low resistivity value is indicated by dark blue to light blue color. The low resistivity value is due to the presence of rocks

containing water. The low resistivity value (below 100 Ohm.m) also indicates that the rock has been weathered, giving potential for seepage in the area. The geoelectrical cross-section obtained for the plinth and main dam area (Figure 5a), 7 points which have potential for seepage are found. Similarly, 7 points have the potential for seepage were also found for the geoelectrical cross section for the plinth (Figure 5b). The geoelectrical cross section for the tunnel shaft (Figure 5c) shows 4 points which have potential for seepage. The same number of seepage points were found on the cross section for intake (Figure 5d) For the spillway area (Figure 5e), the lowest resistivity value is found on the surface. The spillway area has 7 points which have indication for seepage. The locations of seepage points are summarized in Table 2.

Connections between seepage paths is interpreted from the geoelectrical sections (Figure 5). Each cross sections are placed according to its coordinates, then the soil/rock with the same resistivity values are assumed to be connected, i.e., one soil/rock type. There is a common color that runs from the tunnel cross section to the plinth and main dam cross section. From these connections, it can be interpreted that the seepage is continuous and interconnected between all parts of the dam.

The subsurface of the plinth structure (Figure 5b) consists of rock with classes ranging from D (Decomposed rock) to CH (class high rock). The depth of Class D rocks varies from the surface to a depth of 2-10 meters. The decomposed rock is caused by weathering that occurs on the surface. The rock class CH dominates the subsurface of the plinth area up to the drilling depth limit.

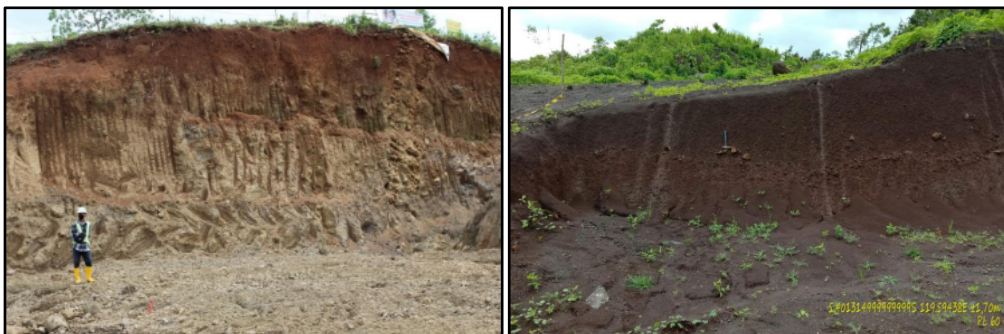
Figure 7. Residual soil found in Pamukkulu dam area, South Sulawesi, Indonesia

The degree of weathering that occurs in the research area is quite high, as residual soil can be found in several places. The thickness of residual soil exposed on the surface varies between 1 to 10 meters (Figure 7). The color of the soil is light brown to dark brown with vegetation in the form of trees and shrubs on the surface of the soil.
